**Flood Control Project Maintenance
Levee Inspections**

Fall 2015 Levee Maintenance Deficiency Summary Report

Sacramento River Basin

Reclamation District No. 2068 Yolano

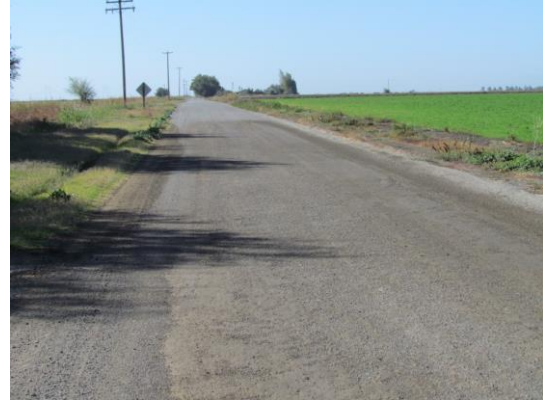
Photo 1 of 1 : FA_2015_RD2068_193_9_20150928_00001.jpg

LM Start	0.04	Rating **	A	Issue No.	9
LM End	0.49	Issue Type +	Ma	Location *	LS
Category	Earthen Levee			GPS Latitude/Longitude	
				Start	End
Item	Vegetation			38.404471 °	38.401440 °
				-121.693680 °	-121.693750 °
DWR ID	DWR_RD2068_01_f_2015_9				
Action/Comments					
Control annual grass and weeds on the levee slopes and easements. Inspector Comments: Vegetation maintained good in this section.

This photo shows the actual start of RD 2068 Unit 1. The levee section is the road way. The levee start at levee mile 0.51.

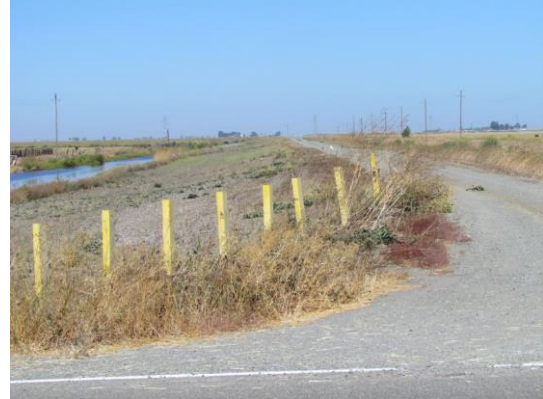
Photo 1 of 1 : FA_2015_RD2068_194_10_20150928_00004.jpg

LM Start	0.01	Rating **	A	Issue No.	10
LM End	0.02	Issue Type +	Ma	Location *	LS
Category	Earthen Levee			GPS Latitude/Longitude	
				Start	End
Item	Vegetation			38.358235 °	38.358368 °
				-121.740387 °	-121.740385 °
DWR ID	DWR_RD2068_02_f_2015_10				
Action/Comments					
Control annual grass and weeds on the levee slopes and easements. Inspector Comments: The unwanted growth is at the gate crossing.

RD 2068 Unit 2 levee mile 0.00 this levee section doesn't have unwanted growth except at the barricade gate crossing.

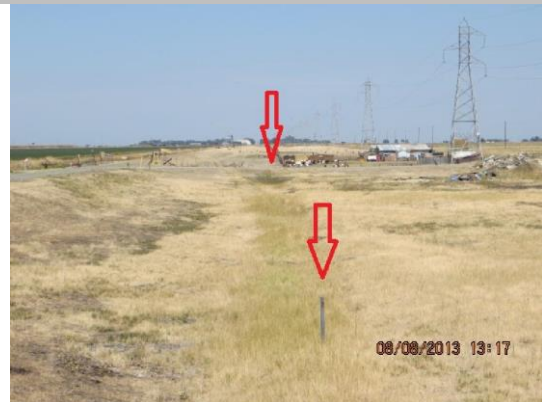
Photo 1 of 2 : UCIP_FA_2015_1645.jpg

LM Start	0.91	Rating **	M	Issue No.	18
LM End	0.91	Issue Type +	En	Location *	LS
Category	Supplemental			GPS Latitude/Longitude	
				Start	End
Item	DWR UCIP Field Study			38.371273 °	38.371273 °
				-121.740138 °	-121.740138 °
DWR ID					
Action/Comments					
Inspector Comments: FS_ID:17531 DS_ID:19355 EP_NO: 8151 FS_HLM: 0.904 Repair Type: Non-Urgent Crossing Status: Indicator Found UCIP Comments: Appears abandoned. Need to verify with pipeline owner. FIELD_STRUCT_DESC: 8-inch steel gas pipe through the levee 3 feet below the crown (Permit No. 8151, 1972). Gasline markers visible on east toe of levee at intersection of levee and Delhi road. FS Date: 08/08/2013

Gasline markers on east side of levee toe looking North.

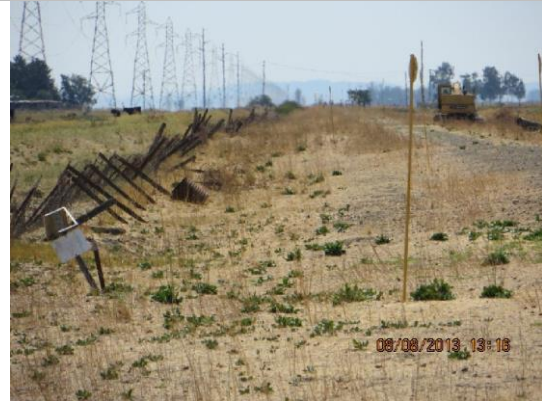
Photo 2 of 2 : UCIP_FA_2015_1646.jpg

LM Start	0.91	Rating **	M	Issue No.	18 (cont)	
LM End	0.91	Issue Type +	En	Location *	LS	
Category	Supplemental			GPS Latitude/Longitude		
				Start	End	
Item	DWR UCIP Field Study			38.371273 °	38.371273 °	
				-121.740138 °	-121.740138 °	
DWR ID						
Action/Comments						
Inspector Comments: FS_ID:17531						
DS_ID:19355						
EP_NO: 8151						
FS_HLM: 0.904						
Repair Type: Non-Urgent						
Crossing Status: Indicator Found						
UCIP Comments: Appears abandoned. Need to verify with pipeline owner.						
FIELD_STRUCT_DESC: 8-inch steel gas pipe through the levee 3 feet below the crown (Permit No. 8151, 1972). Gasline markers visible on east toe of levee at intersection of levee and Delhi road.						
FS Date: 08/08/2013

Gasline markers next to old rail road grade, looking south.

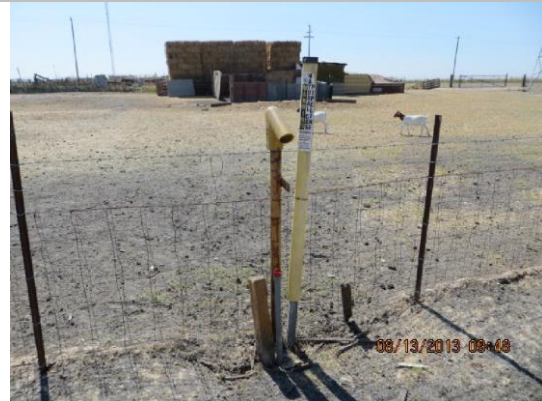
Photo 1 of 3 : UCIP_FA_2015_1647.jpg

LM Start	1.07	Rating **	M	Issue No.	19
LM End	1.07	Issue Type +	En	Location *	LS
Category	Supplemental			GPS Latitude/Longitude	
				Start	End
Item	DWR UCIP Field Study			38.373330 °	38.373330 °
				-121.738530 °	-121.738530 °
DWR ID					
Action/Comments					
Inspector Comments: FS_ID:17532					
DS_ID:19354					
EP_NO: 13028					
FS_HLM: 1.073					
Repair Type: Non-Urgent					
Crossing Status: Indicator Found					
UCIP Comments: Need improved signage on LS and WS shoulders.					
FIELD_STRUCT_DESC: 10-inch steel pipe through the levee 2 feet below the crown. A 4-inch gas line is sleeved through the 10-inch pipe.					
Sign missing from marker post on east slope. 2-inch vent pipe with identification sign located off west bank of levee and off toe of east side of levee at fence (Permit No. 13028, 1981).					
FS Date: 08/13/2013

Vent and signage off WS toe.

Inspector Comments: FS_ID:17532
 DS_ID:19354
 EP_NO: 13028
 FS_HLM: 1.073
 Repair Type: Non-Urgent
 Crossing Status: Indicator Found
 UCIP Comments: Need improved signage on LS and WS shoulders.
 FIELD_STRUCT_DESC: 10-inch steel pipe through the levee 2 feet below the crown. A 4-inch gas line is sleeved through the 10-inch pipe.
 Sign missing from marker post on east slope. 2-inch vent pipe with identification sign located off west bank of levee and off toe of east side of levee at fence (Permit No. 13028, 1981).
 FS Date: 08/13/2013

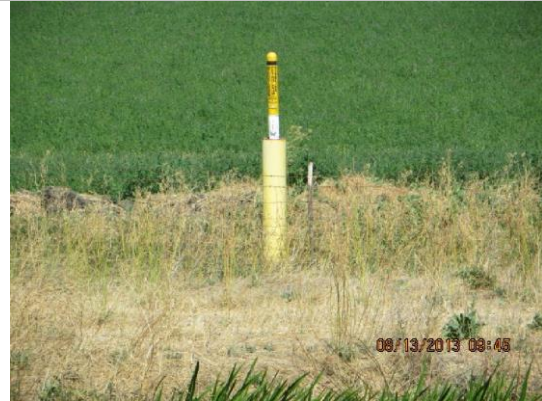
Photo 2 of 3 : UCIP_FA_2015_1648.jpg

Sign marker off LS toe.

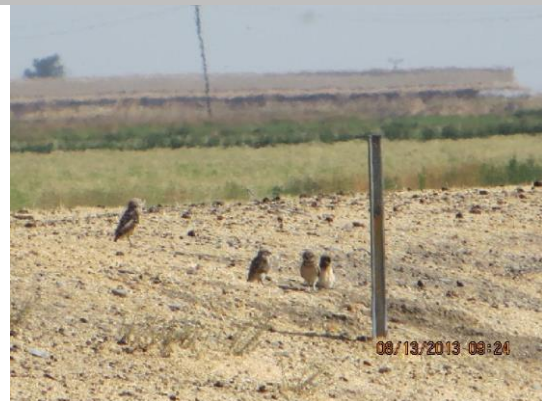
Photo 3 of 3 : UCIP_FA_2015_1649.jpg

Sign post without markings on WS slope.

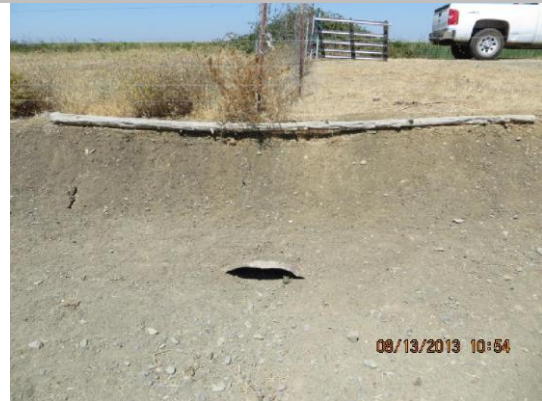
Photo 1 of 1 : UCIP_FA_2015_1523.jpg

LM Start	3.15	Rating **	M	Issue No.	21
LM End	3.15	Issue Type +	En	Location *	LS
Category	Supplemental			GPS Latitude/Longitude	
				Start	End
Item	DWR UCIP Field Study			38.397933 °	38.397933 °
				-121.716406 °	-121.716406 °
DWR ID					
Action/Comments					
Inspector Comments: FS_ID:42725 DS_ID:19352 EP_NO: 10164 FS_HLM: 3.158 Repair Type: Non-Urgent Crossing Status: Found UCIP Comments: Appears abandoned and if so should be done properly. Pipe burried except for small opening. FIELD_STRUCT_DESC: 6 of 6: 48-inch corrugated metal pipe through the levee 4.0 feet below the crown (ABO No. 10164, 1974). Originally included in the O&M manual, 1962. FS Date: 08/13/2013

Pipe buried but visible at toe of east side of levee.
